Kriegsmarine U-Boat Colours & Markings

Dougie Martindale
Accurate Model Parts

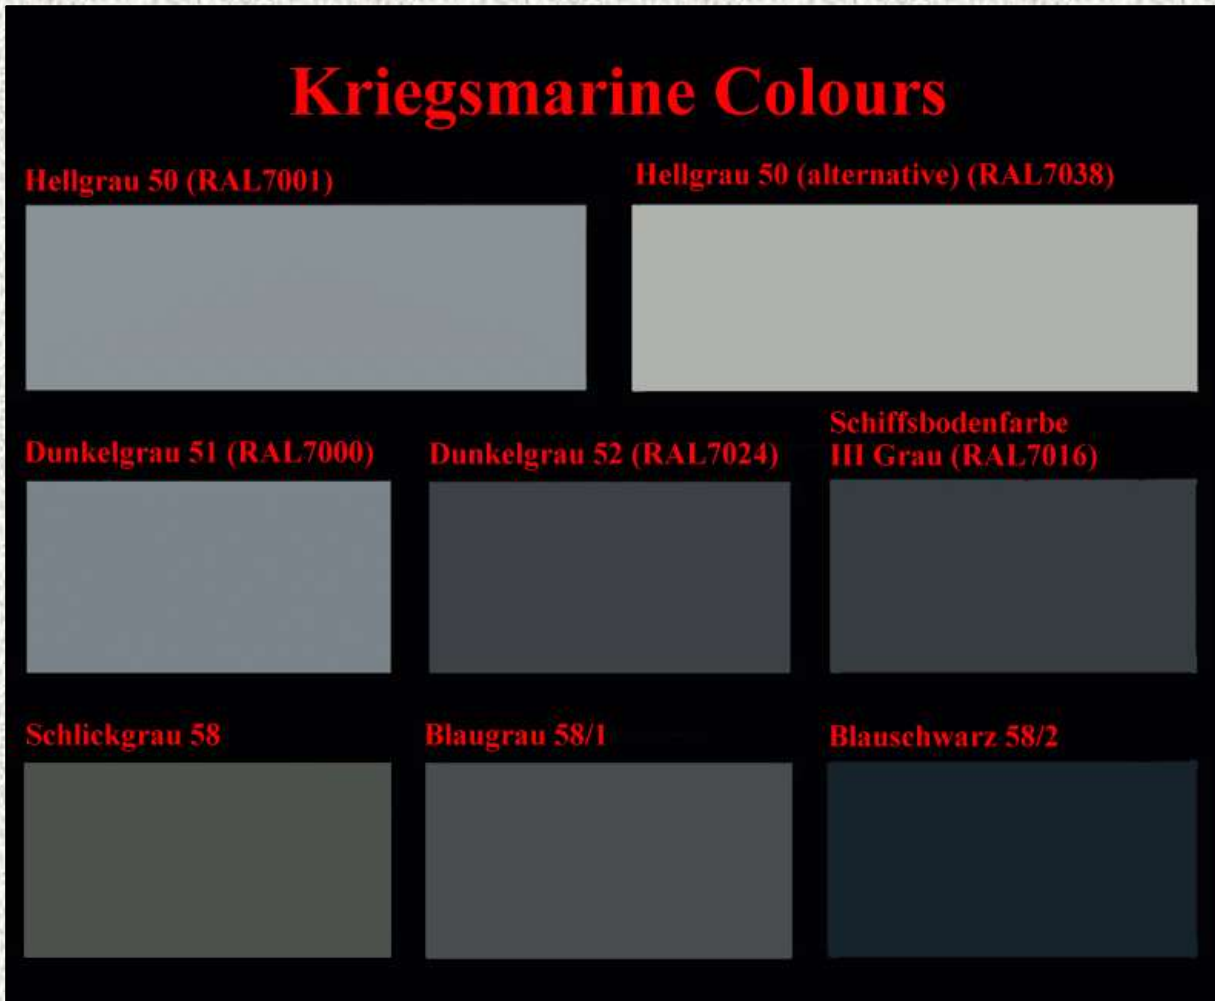
Above: The colours in the guide above are based upon the RGB (red, green, blue) values of the RAL colours. These values were obtained from a diskette purchased from *Multicolor UK Ltd.*, RAL's sales partner in the UK. For the Kriegsmarine colours which had no RAL code associated with them (the bottom three), the colours were matched as best as possible from the two-part set of Kriegsmarine paint chip cards produced by *Snyder & Short Enterprises*. Note that variances will occur due to monitor settings.

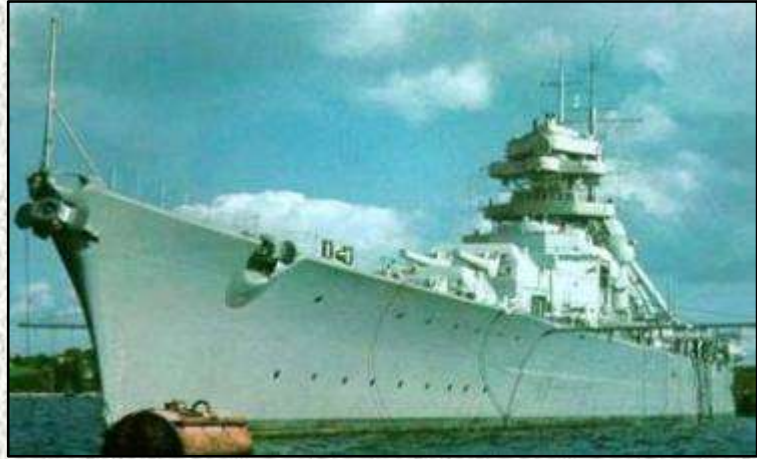
Above (1): This 1940 colour photo of the mighty Kriegsmarine battleship *Bismarck* is useful to us because the paint regulations specify the paint colours we see before us. The hull is *Dunkelgrau 51* and the superstructure – looking very light under the shining sun – is *Hellgrau 50*. The bootline just above the water is not black but the dark grey *Wasserlinienfarbe W.L. III Grau*. This paint has the same number, 23b, as the paint used on the lower hulls of U-boats, *Schiffsbodenfarbe III Grau*. They are in fact the same paint, with the same colour (RAL7016), merely with different names.

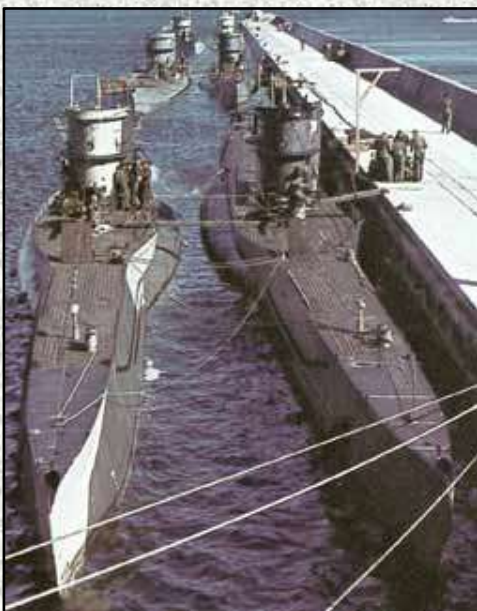
Left (2): Comparisons between the *Bismarck* photo and this 1942 photo, also taken in strong sunlight, show similarities between paint colours. The medium blue-grey colour on the boat on the front right (U 335), and on the VII and IX (U 163) in the second row, is similar to the *Dunkelgrau 51* hull of the *Bismarck*. The light grey on the camouflaged U 253 on the front left, and the two U-boats in the third row, appear similar to the *Hellgrau 50* on the *Bismarck*'s superstructure. Note also the wooden deck colour, covered later in the article.

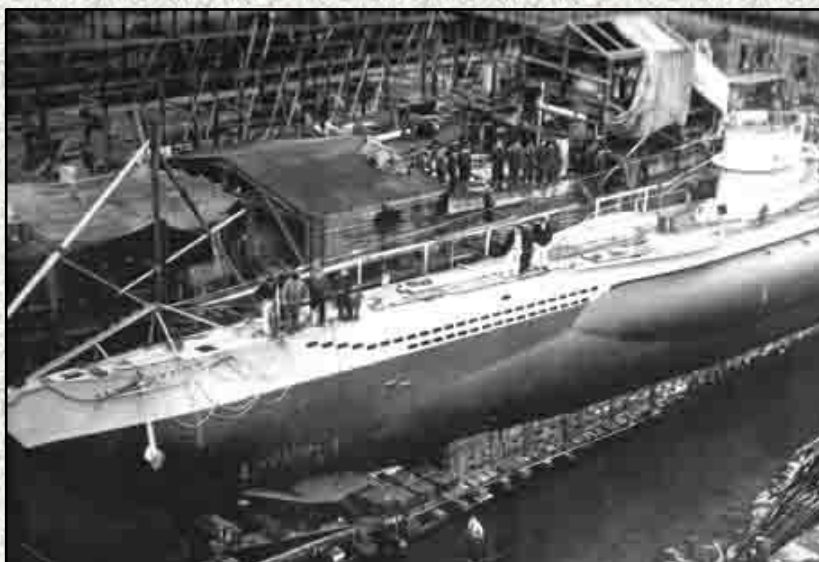
Above (3): The division between the lighter upper grey and the lower darker grey can clearly be seen on U 69. As was common practice, the whole of U 69's saddle tanks were painted in the lower anti-fouling colour.

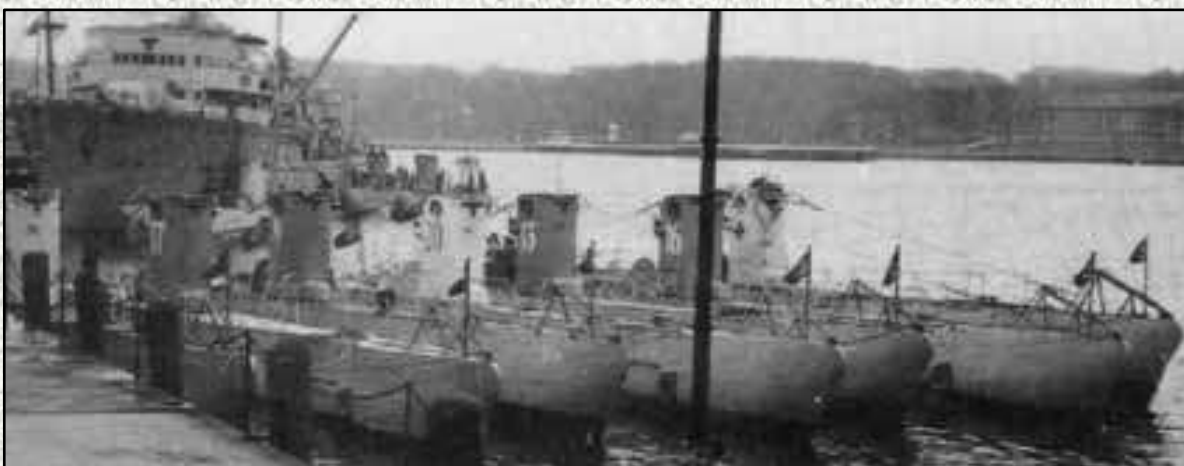
Above (4): Photos such as this one, in which the colour of the U-boats can be compared to the *Dunkelgrau 51* hull and *Hellgrau 50* superstructure of the tender, are valuable tools in determining U-boat colours. Two different colour schemes are evident upon these pre-war Type IIs. In the front row, four have *Dunkelgrau 51* upper hulls and *Dunkelgrau 51* towers, while three have *Dunkelgrau 51* upper hulls and white towers.

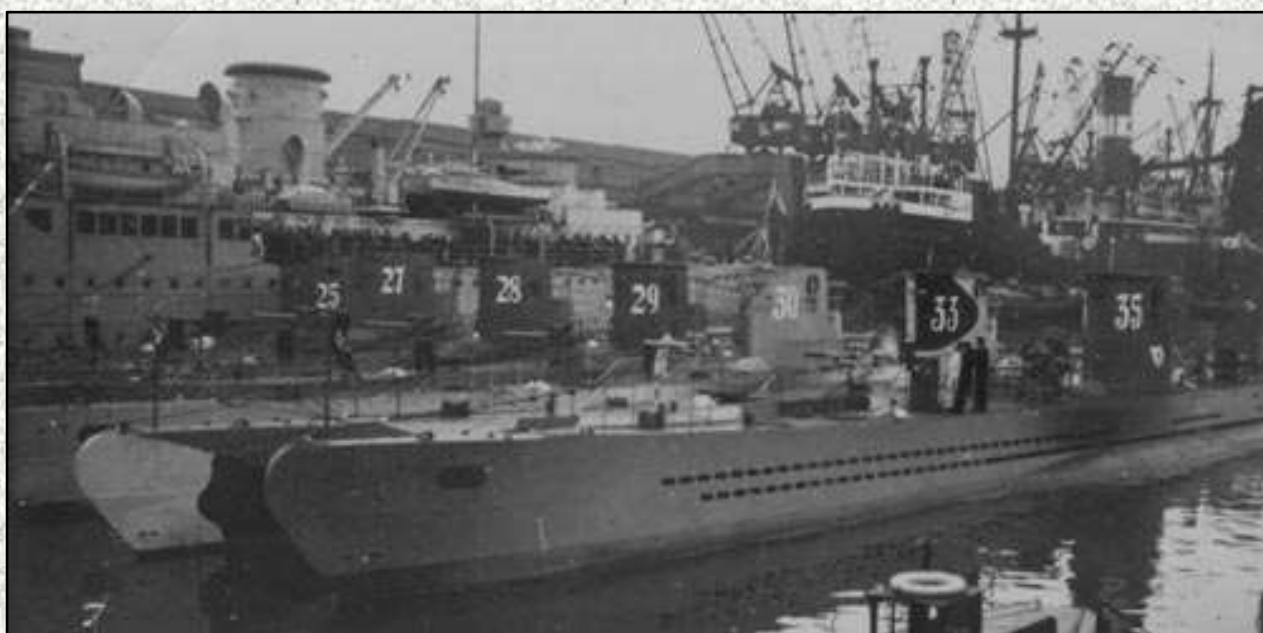
Above (5): The *Saltzwedel* Flotilla in Bremen during 1937. Once again different schemes are evident, and again the presence of the tender helps us with paint colours. Most of the boats are darker than the tender's *Dunkelgrau 51* hull; they may be in *Dunkelgrau 52*. U 33 is painted in alternative Spanish Civil War markings.

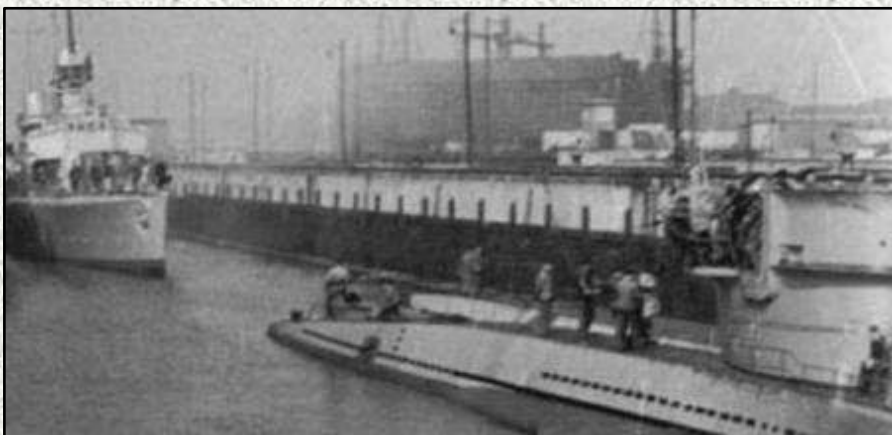
Left (6): If we could see only the right half of this photo, may we have assumed the upper colour of the original VII was the light grey *Hellgrau 50*? The ship in the left hand side provides us with a vital clue. Once again the ship has a *Hellgrau 50* superstructure and a *Dunkelgrau 51* upper hull. The U-boat was therefore probably in *Dunkelgrau 51*.

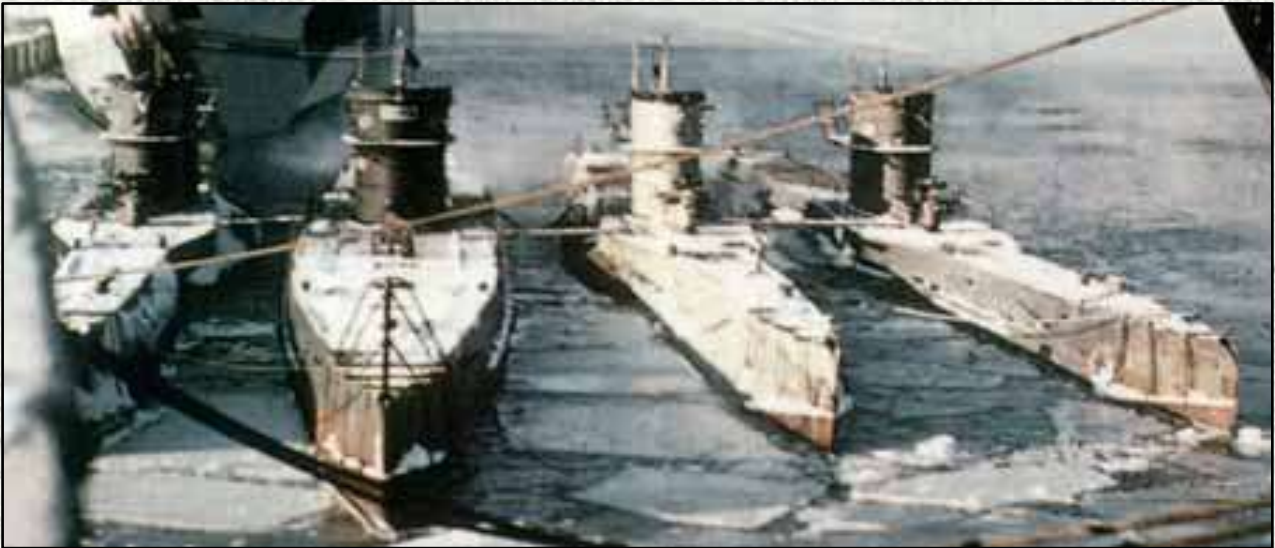
Above (7): The U-boats seen here in Gotenhafen have rusty protective caps over their bows to prevent damage from ice. The decks are covered under a layer of snow. The Type IX second from the left, U 37, looks particularly

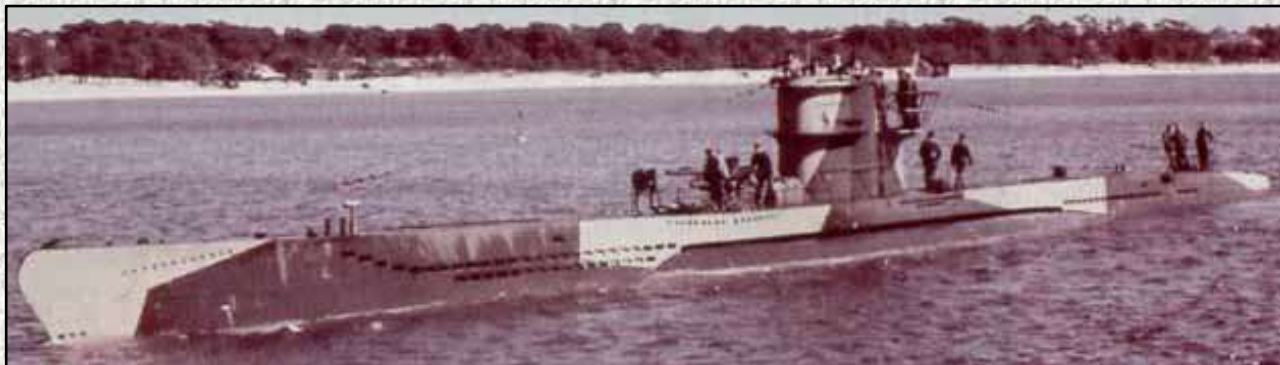
Above (8): U 253 in 1942, with a distinctive camouflage scheme. The RAL7016 used upon the lower hull was extended over some areas of the upper hull and conning tower of U 253. The light grey looks like *Hellgrau 50*.

Often this camouflage would consist of dark grey stripes, bands, patches, lines or jagged splotches over a lighter grey. Sometimes the camouflage would extend over the whole of the upper hull and conning tower, whereas in other cases the camouflage was limited to the conning tower only. Though feathered edges were used in the sprayed-on wavy striped camouflage schemes, it was much more usual for hard edges and straight lines to be used. Below is a list of the assorted styles of camouflage schemes that were seen upon U-boats of differing types. All schemes, other than those specified, had hard edges.

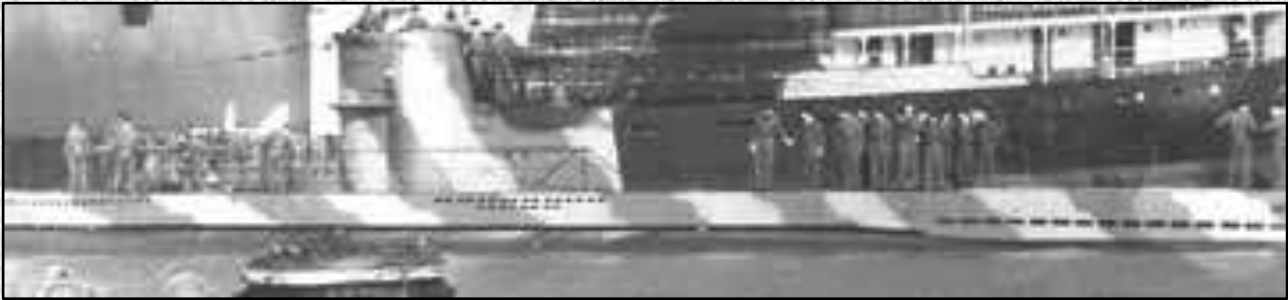
Above (9): Due to the aesthetic camouflage scheme employed upon U 201 (seen here in Brest in 1941), the boat is a popular choice for model-makers. Darker grey wavy stripes were sprayed on over a lighter grey on a few Atlantic-based U-boats. The number of stripes varied from boat to boat. Note that the darker grey was still lighter than the dark grey anti-fouling *Schiffsbodenfarbe III Grau* on the lower hull.

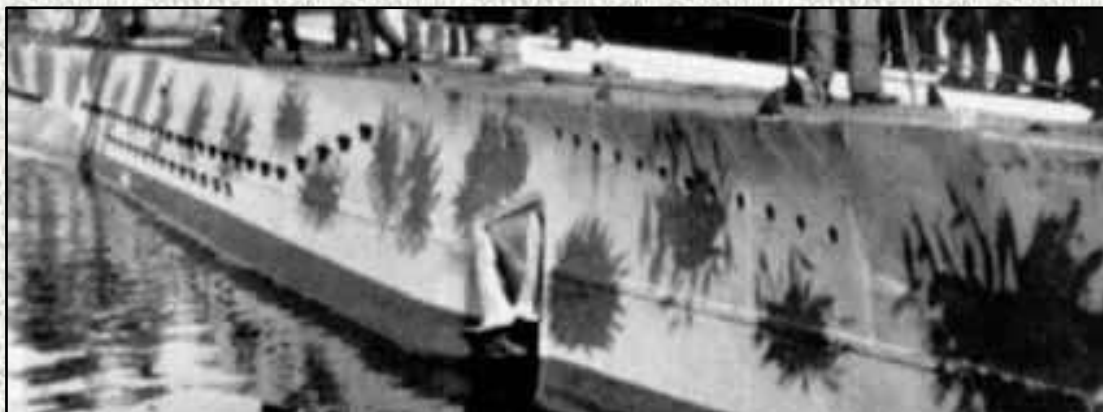
Above (10): An example of the dark splotches with jagged edges that were added to the upper hull and the conning towers of a number of boats serving in the Mediterranean.

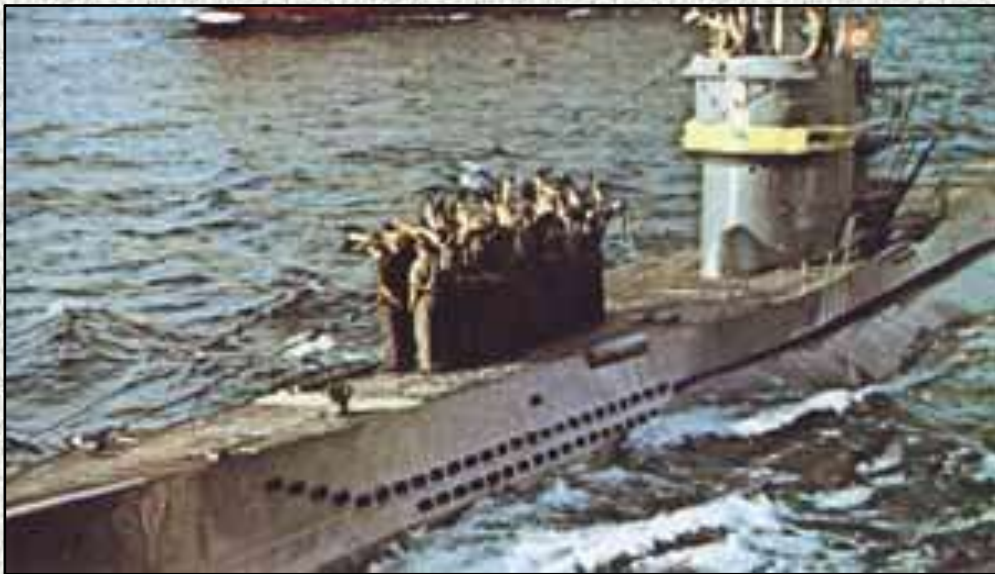
Left (11): The yellow band above U 749's spray deflector and the other band on the foredeck, just behind the capstan, indicate that the boat was involved in training. Not visible in this image is the other yellow band that would have been present on the aft deck.

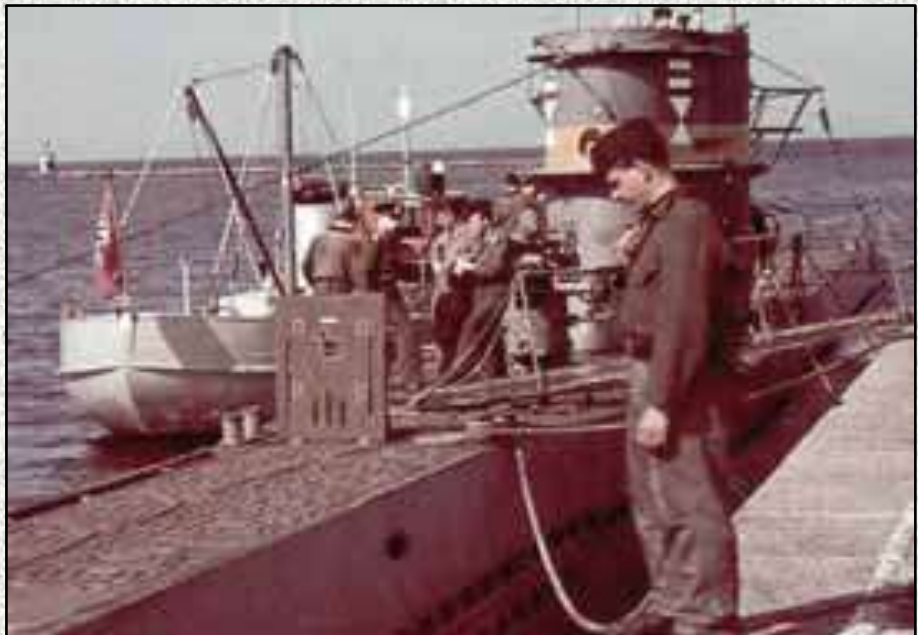
Above (12): U 302 in the Baltic during the late summer of 1942. The yellow band indicates that the boat was assigned to training at this time. The white triangles and lines on the tower are UAK tactical markings. Note that the grey above the yellow band is darker than the grey on the lower half of the tower and hull sides.

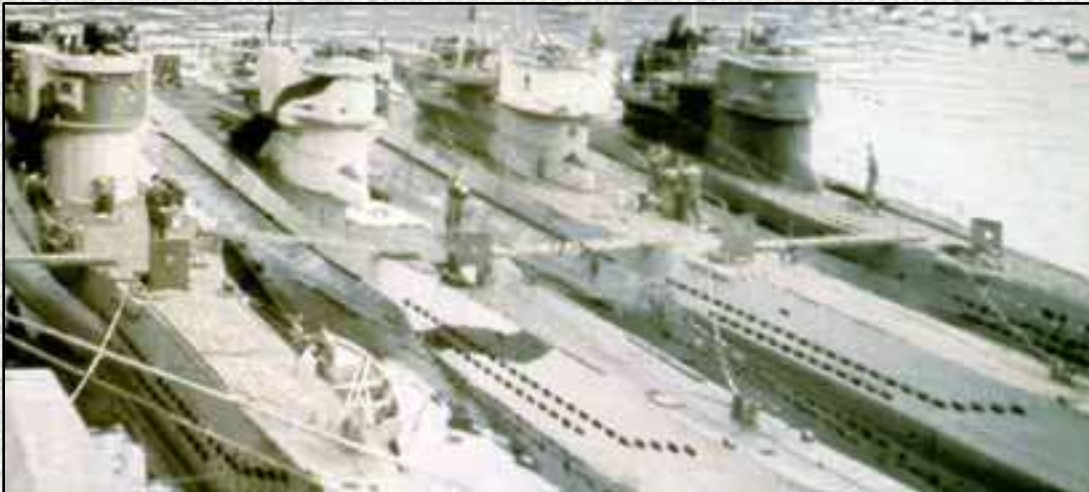
Above (13): This photo shows, from left to right, U 362, U 711, U 278 and U 997, on the 30th July 1944. On the two middle boats, the upper half of the fairing in front of the conning tower (which housed the magnetic compass) is black or dark grey.

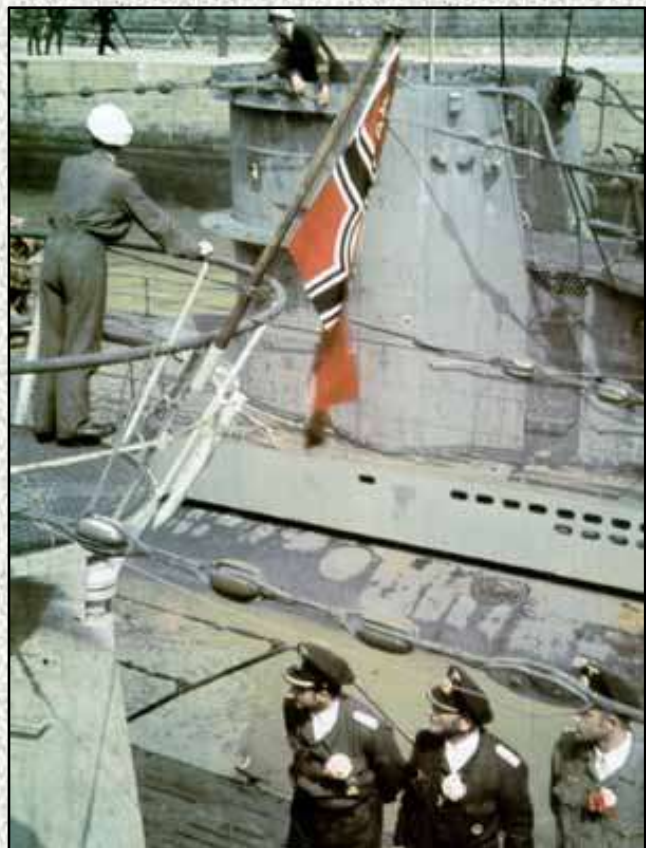
Vertical stripe behind rungs - A rectangular area surrounding the area behind the rungs on the tower sides was very often painted black or dark grey on training boats. This practice may have been in place because the toes of the

sailors' dirty boots would smudge the grey paint when climbing up and down the rungs. On U 751 this area was silver in colour. This practice was less common on frontline boats, perhaps because the dark stripe would be visible against the lighter grey background of the tower.

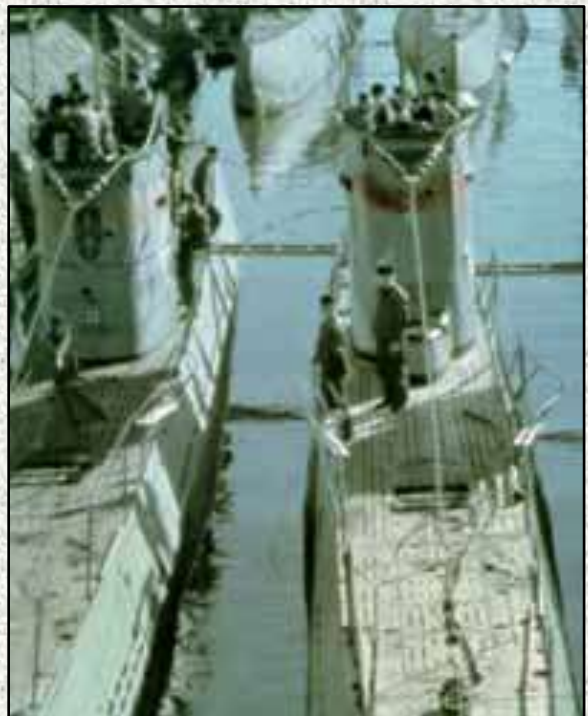
Above (15): School boats of the 21st U-Flottille in Pillau in 1943. The thin black stripe around the base of the conning towers of these *Dunkelgrau 51* Type IIs is evident. The stripe on the boat to the left - possibly U 61 - is thinner than on the boat to the right.

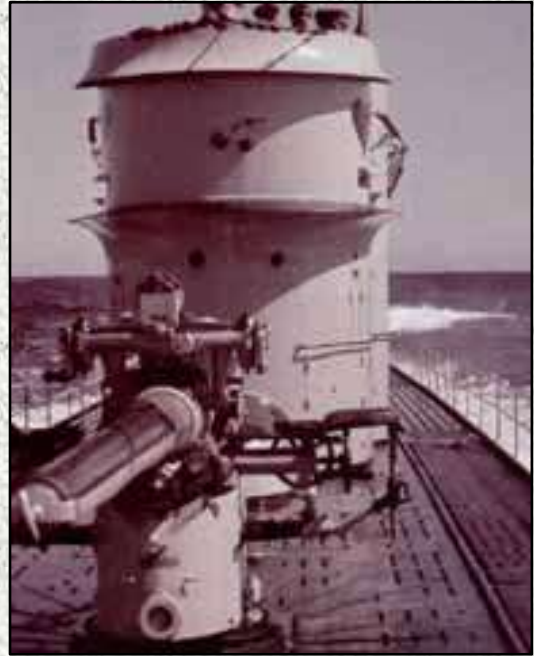
Above (16): A pristine U 164 in 1942. The upper half of the barrel, the upper half of the mounting upon which the removable elevation and traverse sights would sit, and the top half of the controls and gearing arms are all black. Just behind the gun, at the front of the conning tower, can be seen the fairing which housed the magnetic compass. The upper half of the fairing is also black. The light grey looks like *Hellgrau 50*.

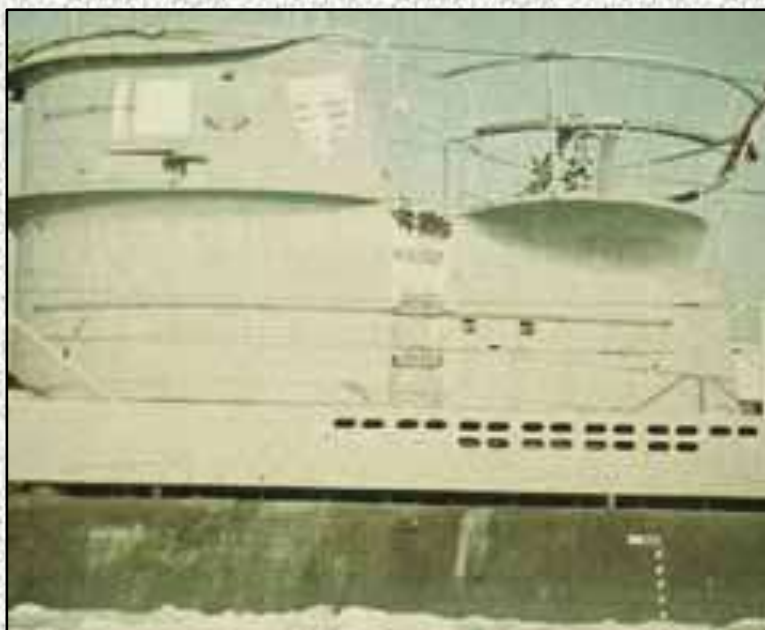
Type VIIs - Three sets of waterline depth numerals were marked upon both sides of the hull, making a total of six. These consisted of small white numerals that were aligned vertically. The first set was located a few feet aft of the bow, the second on the saddle tanks, and the third was a few feet forward of the stern. The first and second sets were of the same design. The top numeral, 0, started roughly at the division between the two greys, and the markings continued down the hull every 10cm to 1 (0,9,8,7,6,5,4,3,2,1). The third set, at the

STARBOARD			PORT		
		4			4
0	0	3	0	0	3
9	9	2	9	9	2
8	8	1	8	8	1
7	7	0	7	7	0
6	6	9	6	6	9
5	5	8	5	5	8
4	4	7	4	4	7
3	3	6	3	3	6
2	2	5	2	2	5
1	1	4	1	1	4
A	B	C	D	E	F
A = STARBOARD FORWARD			D = PORT FORWARD		
B = STARBOARD MIDDLE			E = PORT MIDDLE		
C = STARBOARD REAR			F = PORT REAR

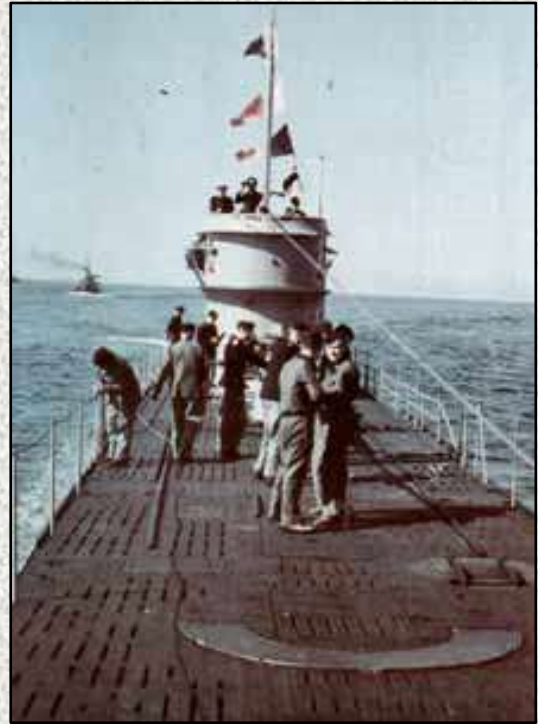
Above (18): The pristine looking Type IX U 128, with a *Hellgrau 50* tower, in May 1941. The freshly-stained wooden deck looks dark, with only a tinge of brown showing through. The metal hatch on the right of the photo, and the C-shaped metal part at the bottom of the photo, have been painted black.

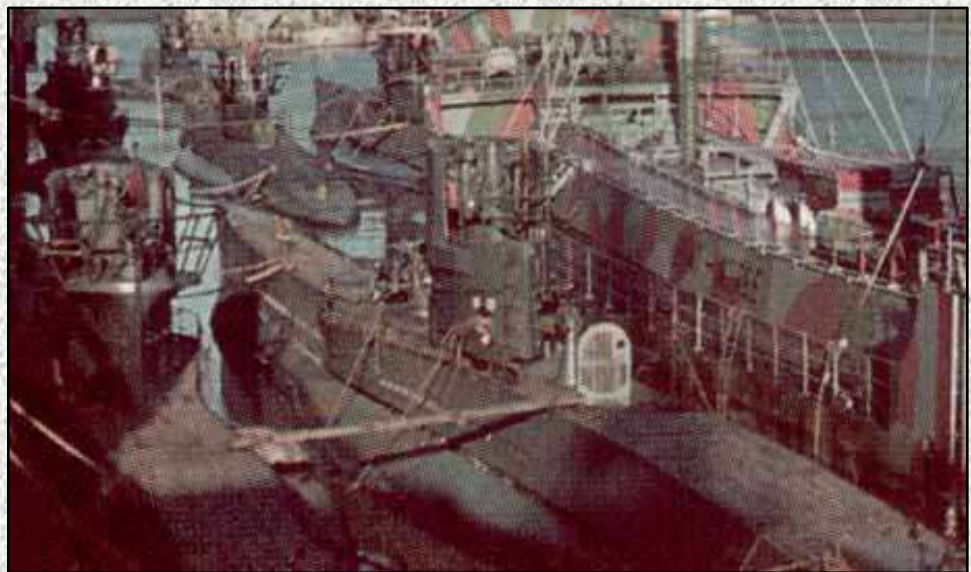
Below (19): The wooden deck colour can be seen on the U-boats in the foreground of this photo, taken in Drontheim in 1942. More brown is apparent on the stained decks than on the photo of U 128 above. Another interesting aspect is that all the U-boats are painted in the same dark grey paint.

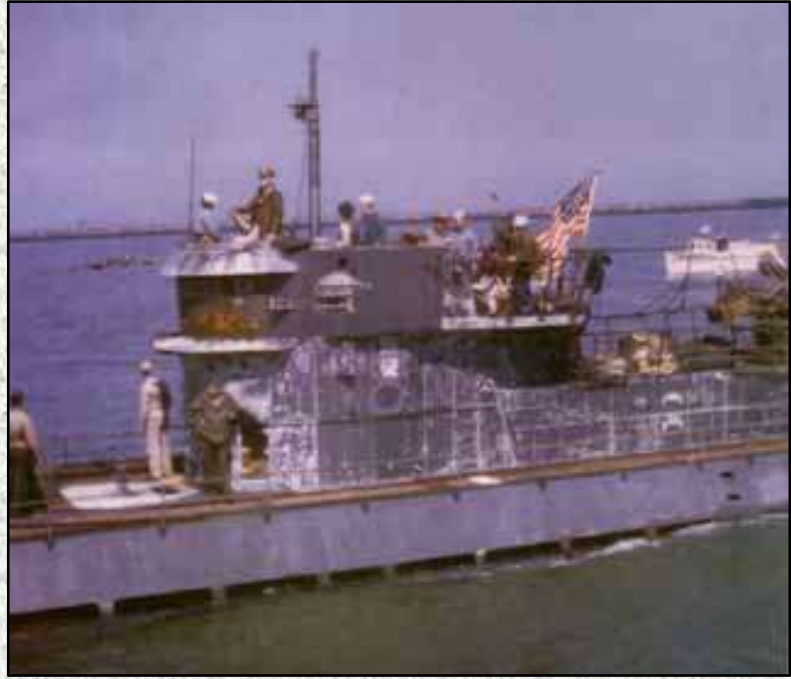
Above (20): The dark blue paint (*Blauschwarz 58/2?*) on U 805's tower has peeled away from the galvanised steel parts of the tower very badly. In contrast, the medium blue-grey paint (*Dunkelgrau 51? or Blaugrau 58/1?*) on the steel upper hull has fared much better. This photograph of the surrendered Type IXC/40 was taken on the 14th May 1945 near Portsmouth, Virginia.

Paint peeling - When U-boats were subjected to heavy weathering, their top layer of paint would peel off in patches. This would reveal either the older paint or the red lead preservative beneath. As discussed later, the Germans sometimes used grey as the colour of their anti-corrosion undercoats in preference to red. The first area for this peeling to occur in was often the bow and/or the waterline, where water would splash against the hull and peel away the top layer of paint. Bumps and scrapes when manoeuvring in harbour would also have resulted in paint chipping and flaking away. Later in the war, the poor quality paint and undercoat did not adhere well to the galvanised steel used on some sections of conning towers. When U 505 and U 805 arrived in American ports the paint on the galvanised steel parts of their towers had peeled very much more heavily than on other areas.

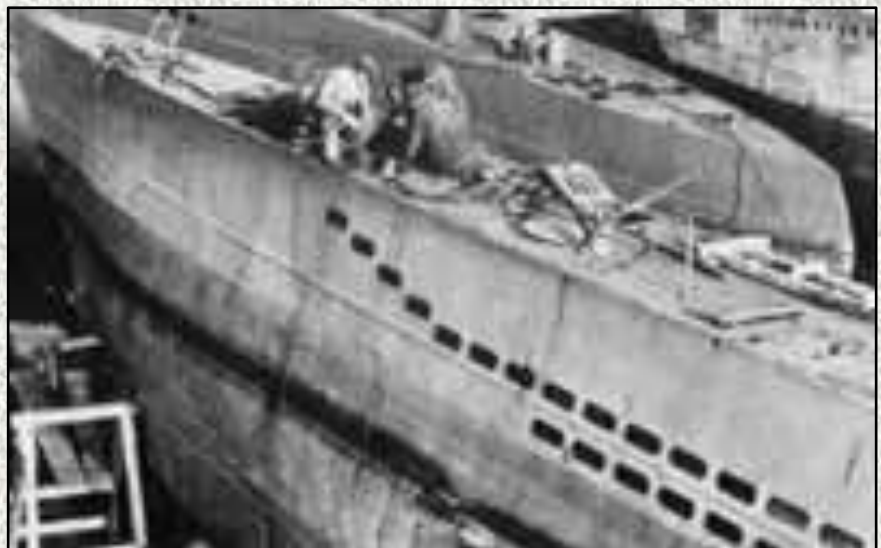
Below (21): The black horizontal line on this unidentified Type VIIC in dry-dock is a "grassweeds" line. It has built up on top of the dark grey anti-fouling paint, and is located well below the division between the two greys.

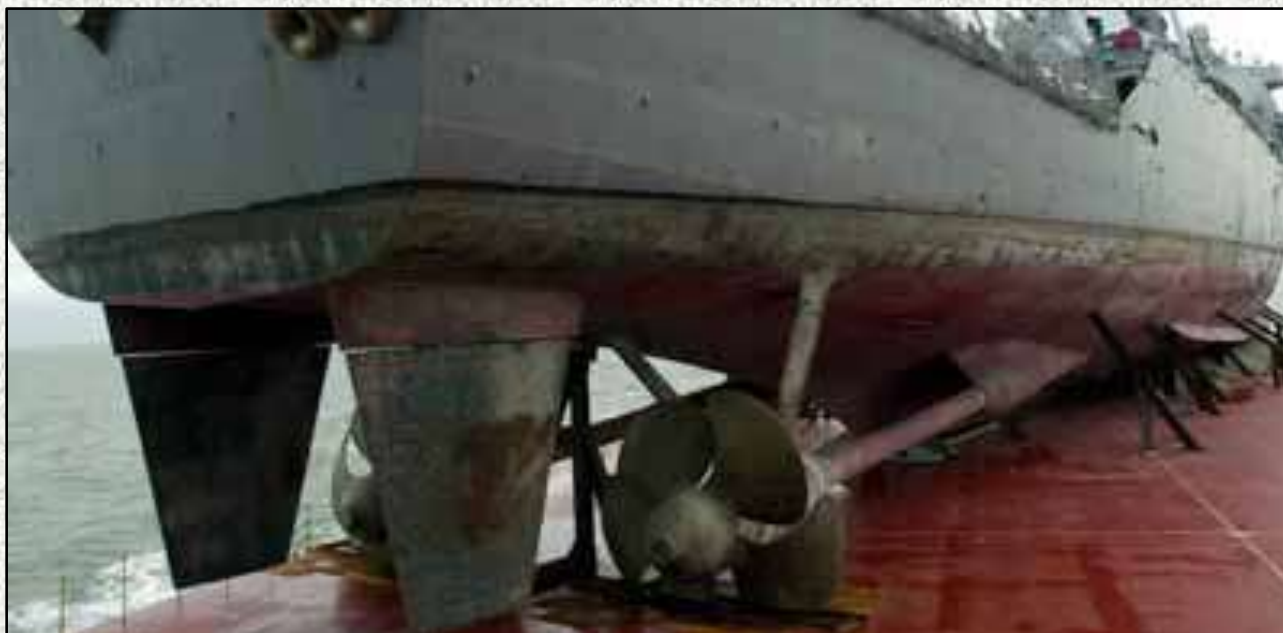
Above (22): A grassweeds line of assorted colours has built up over most of the black bootline on the *USS Cole*. Other plantlife is visible on the starboard rudder. When weathering ship models, many modellers neglect the plantlife that builds up on the lower hulls of vessels.

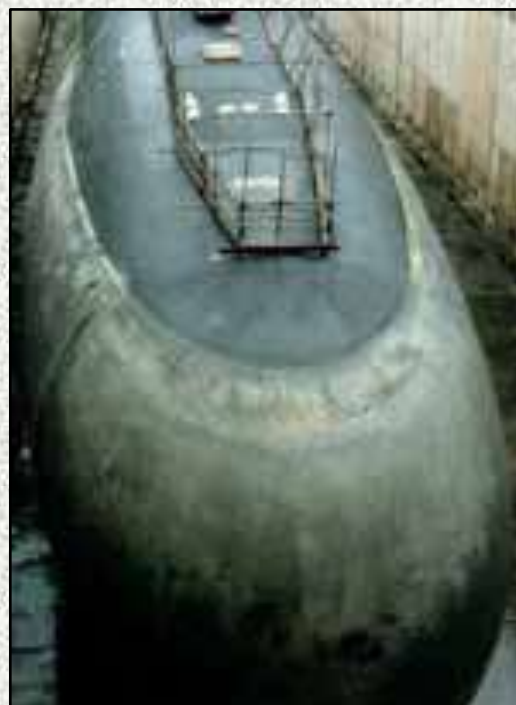
Paint peeling - As with the paint above the waterline, the anti-fouling paint was prone to flaking or peeling away when worn. This would expose the older paint or even the anti-corrosion undercoat beneath.
